Owl Inspections LLC

Property Inspection Report

, Coeur d'Alene, ID 83815
Inspection prepared for: Sample
Date of Inspection: 5/2/2023 Time: 10:30 AM
Age of Home: 56 Size: 2432
Weather: Cold and clear. 37F

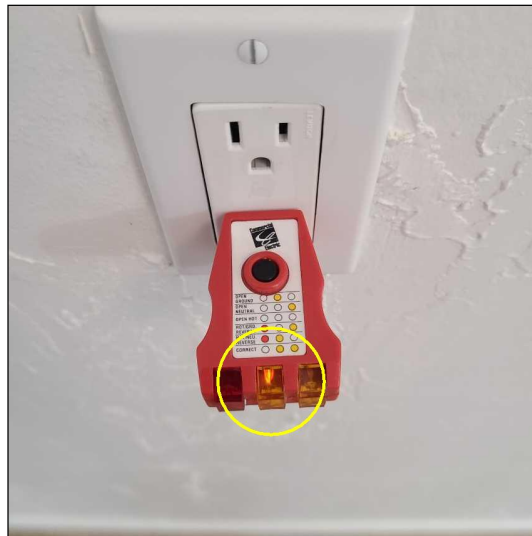
- Open ground- receptacle in basement
- The kitchen receptacle for the refrigerator is not **GFCI** protected. Located directly above refrigerator water line.

Open Ground on outlet in basement living area.

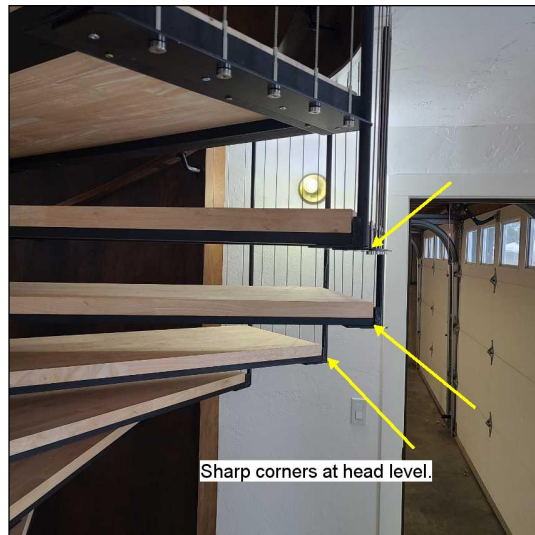
- **Wrought iron spiral stairs promote head injury in basement. Stair tread is close to access door with sharp metal corners, at and below average head level. This is a safety concern.**

Low stair treads. SAFETY ITEM

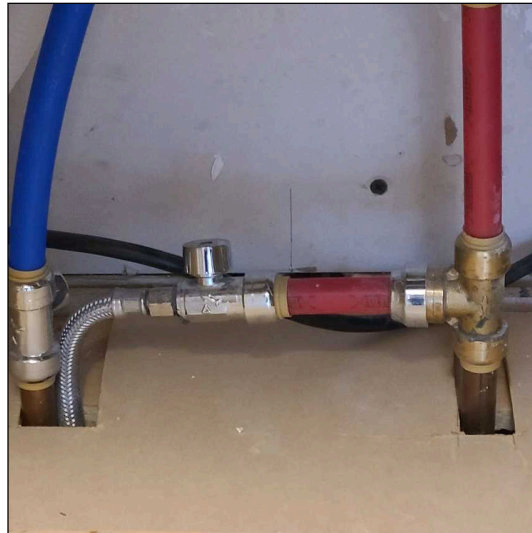
- Refrigerator water supply plumbed from hot water line.

Refrigerator water supply line under kitchen sink.

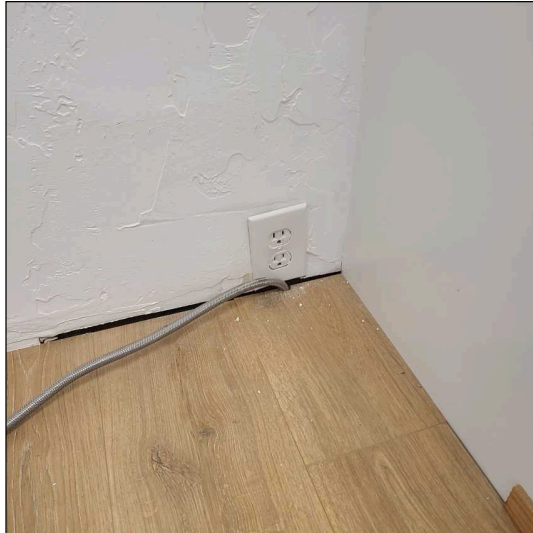
- No GFCI protection present, suggest installing GFCI protected receptacles for safety.

Refrigerator water line under non GFCI outlet.

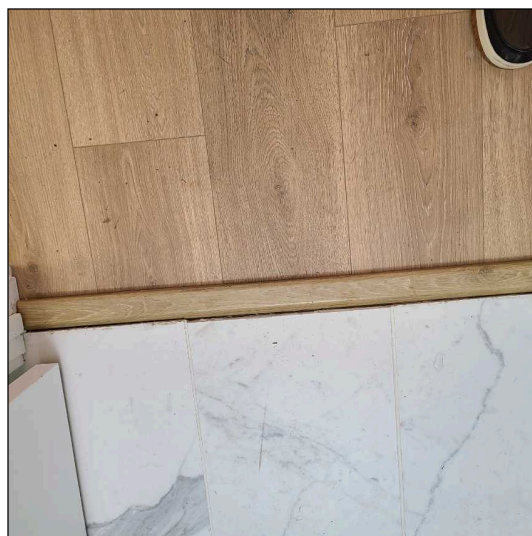
- **Possible trip hazard. Transition from master bathroom to bedroom is incorrect. This is a safety concern. Suggest repair/replacement as needed to ensure safety.**

Improper floor transition.

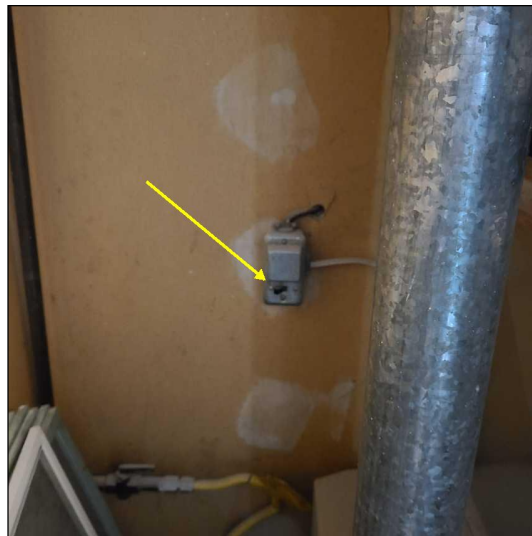
- Fuel Furnace: Last service date is over one year ago, or is unable to be determined. Although this unit appears to be operating properly from controls, there are areas which cannot be seen without specialized equipment and training. One such area is the combustion chamber / heat exchanger where cold air blows across the "fire box", becoming the hot air that circulates throughout your home. During the life span of any furnace, this metal wall may develop a crack or a broken weld, allowing carbon monoxide to circulate throughout the home. This is why furnace specialists recommend a complete inspection annually; consider having unit inspected by certified HVAC technician.

Heater electrical shut off switch

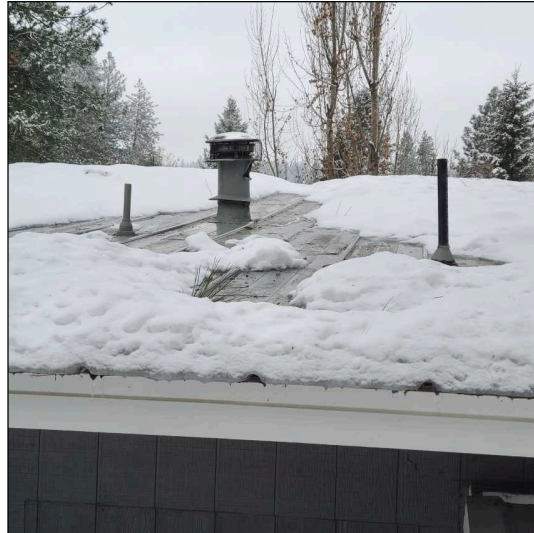
- Metal double wall chimney vent pipe noted.

Furnace chimney

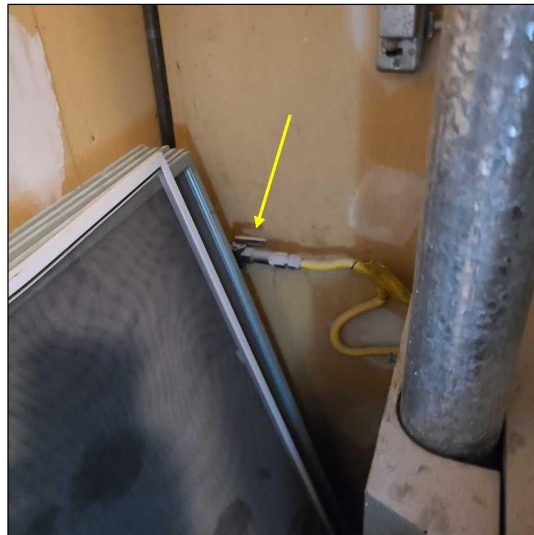
- Gas shut off valves were present and functional.

Furnace gas shut off

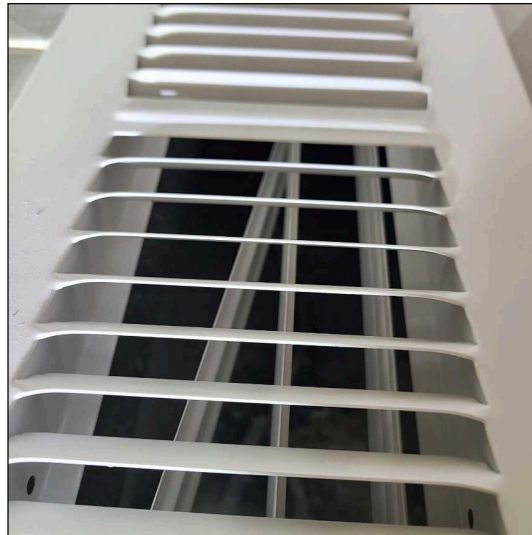
- There is a bent air grill. This is a cosmetic situation and does not effect the operation of the grill.

Basement bathroom register.

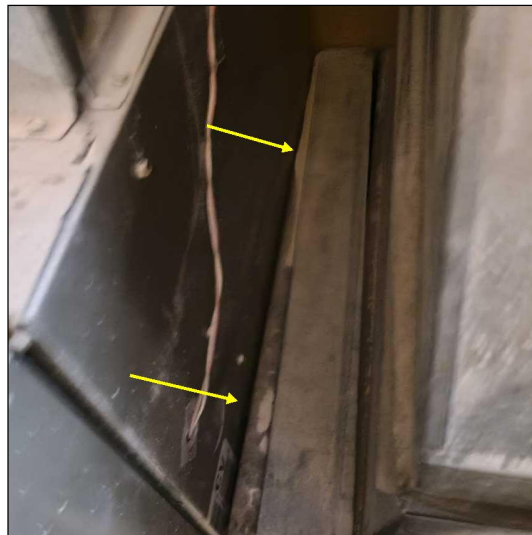
Furnace filter slot

• **MAINTENANCE:** The air filter(s) should be inspected at least monthly and cleaned or replaced as required. There are two types of filters commonly used: (1) Washable filters, (constructed of aluminum mesh, foam, or reinforced fibers) these may be cleaned by soaking in mild detergent and rinsing with water. Or (2) Fiberglass disposable filters that must be **REPLACED** before they become clogged. Remember that dirty filters are the most common cause of inadequate heating or cooling performance.

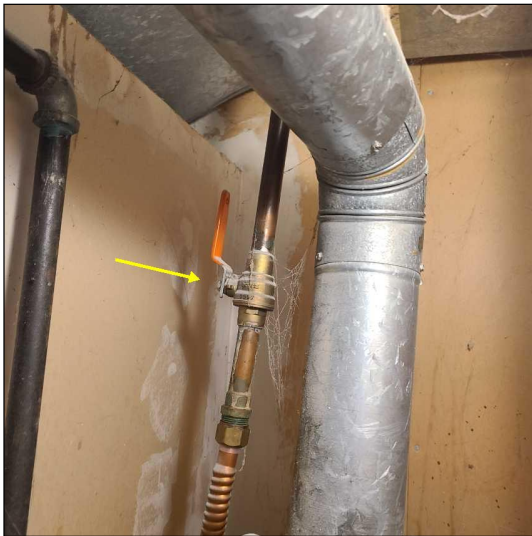
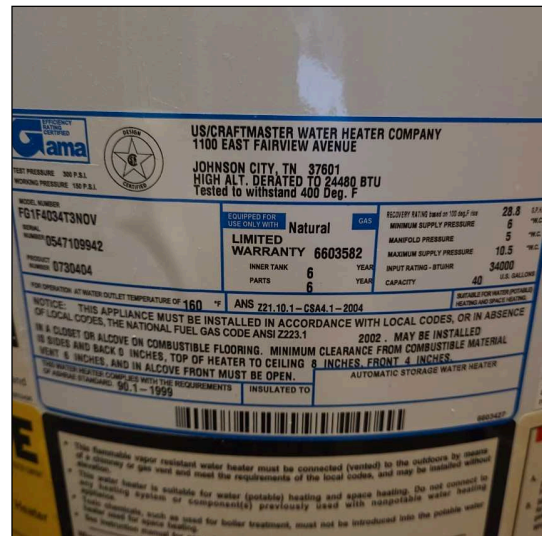
- Water heater is past the end of its typical service life. Highly recommend replacement.
- IMPROVE: A 40 gallon water heater is somewhat small for a home of this size. Recommend installing a larger tank or tankless system when a new water heater is needed.
- Water Source: Public
- **No Smoke or Carbon Monoxide detector in vicinity.**

Hot water heater water shut off.

Hot water heater label

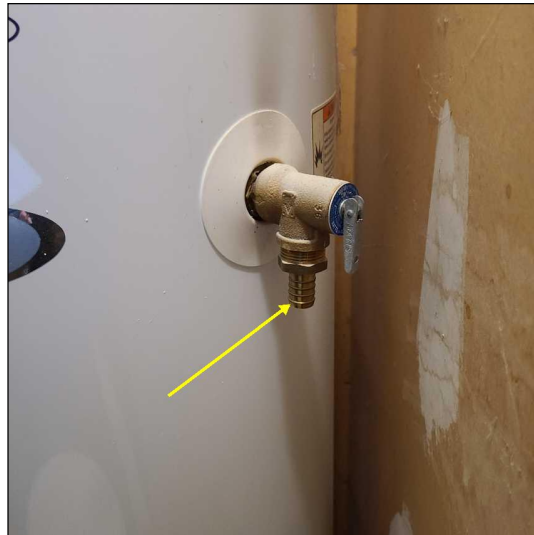
- The Temperature Pressure Relief Valve (**TPRV Valve**) does not terminate within 6" above the floor. This safety valve releases water (and thus relieves pressure) if either the temp or pressure in the tank gets too high. The TPR valve discharge tube must be made of copper, iron, or CPVC (NOT regular **PVC**). It must terminate within 6" above the floor--the end cannot be threaded or have a fitting.

TPR valve not plumbed.

- The extension at the water heater relief valve is missing. This is a potential scalding concern as water can discharge improperly. Recommend installing the proper type of relief extension to discharge within 6 to 8" from the floor.

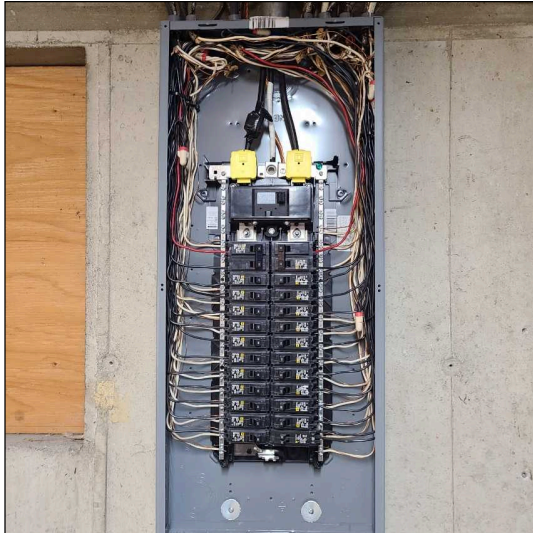
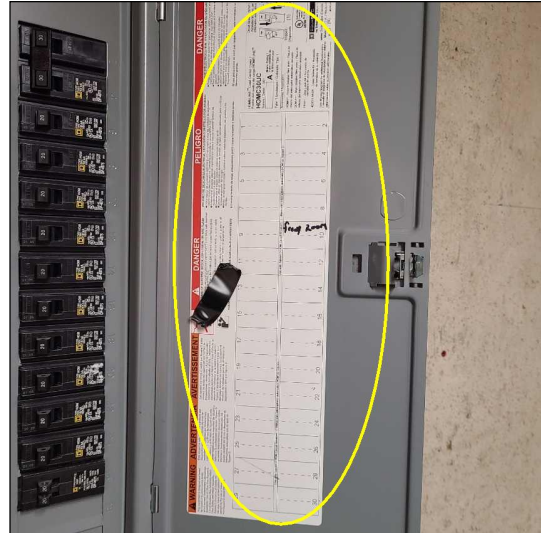
- Panel breakers were not labeled.

Electrical panel

Electrical panel labels.

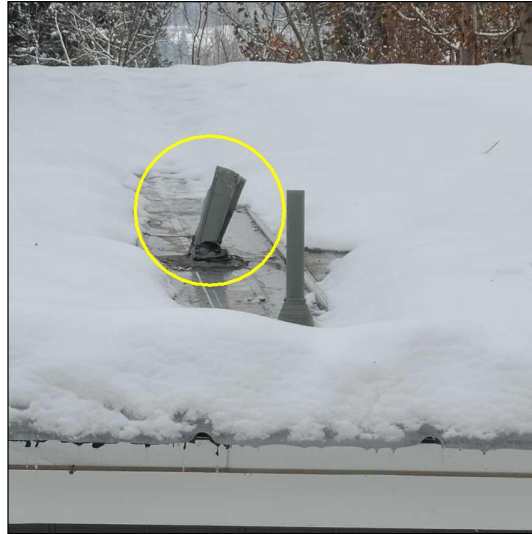
- Semi-flat roof area should be kept clean to avoid leaks, snow loading or ice damming.
- Partially snow covered, not fully inspected.
- Roof vent bent and appears damaged.

Bent roof vent. Unknown origin.

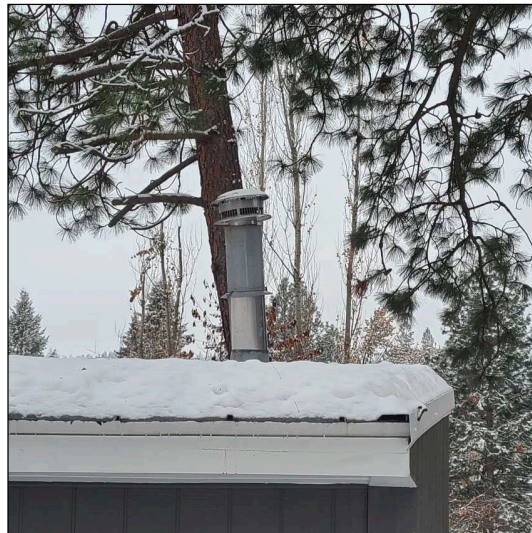
- Metal chimney liner observed. No heat source attached to this chimney.

Chimney has no source within home.

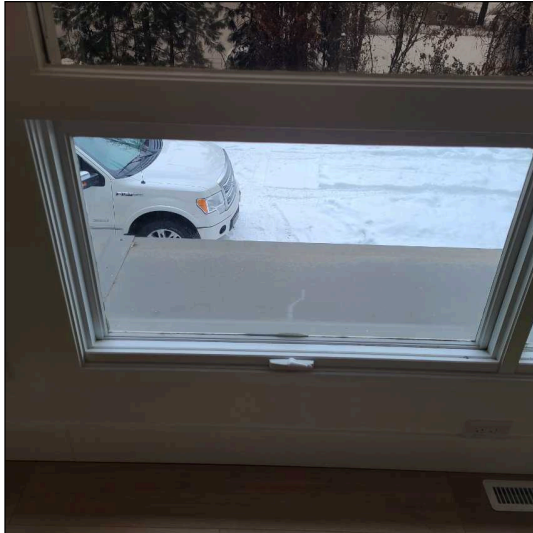
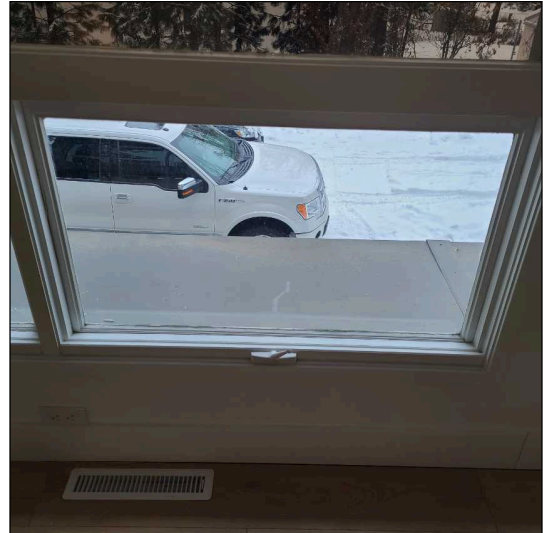
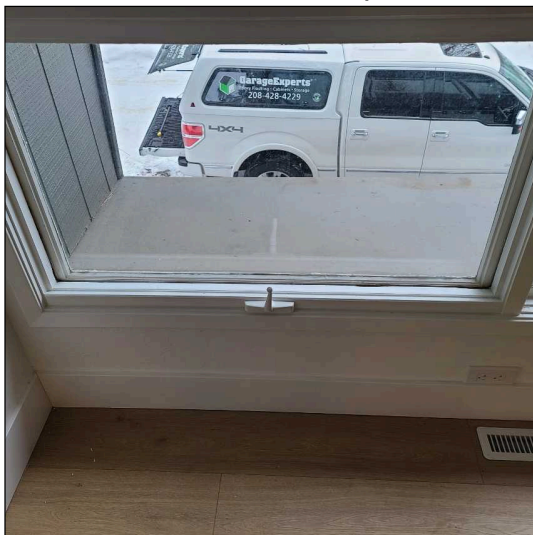
- Some window screens missing. Check with seller to determine if they are on the property.
- Window will not open.
- **Window hardware damaged.**

Window will not open.

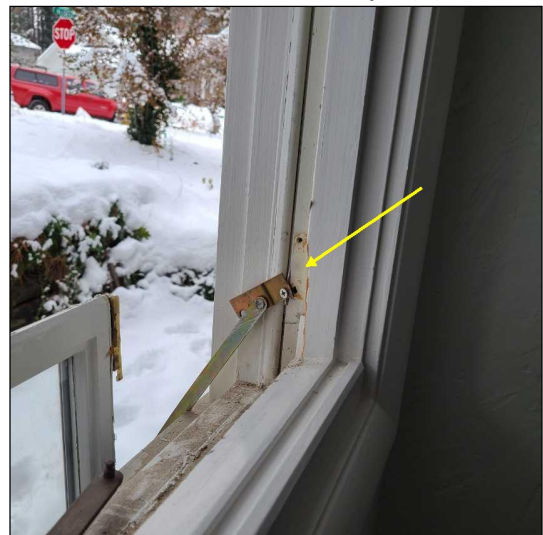
Window hardware damaged.

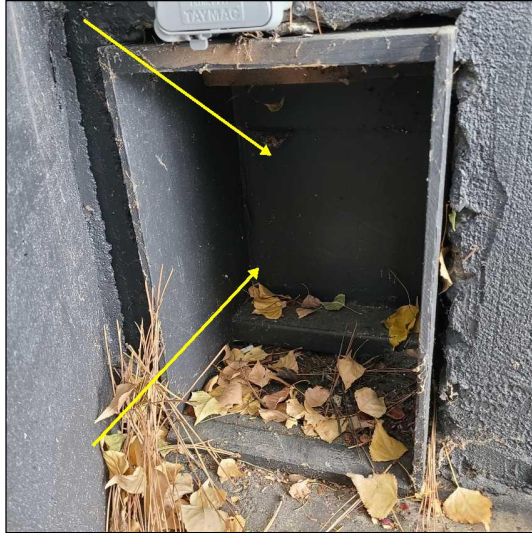
Opening in west wall exposing interior drywall to elements.

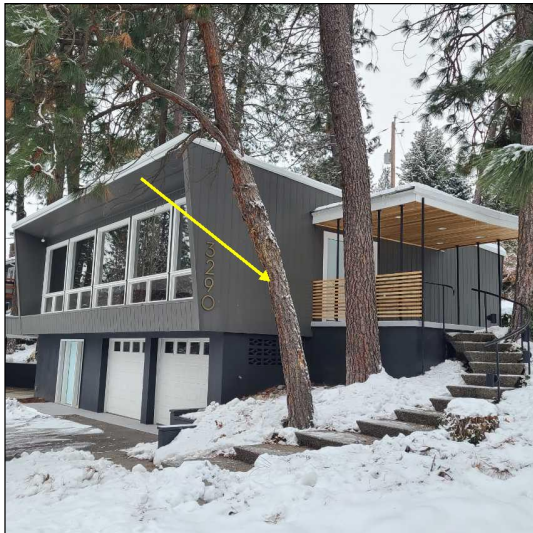
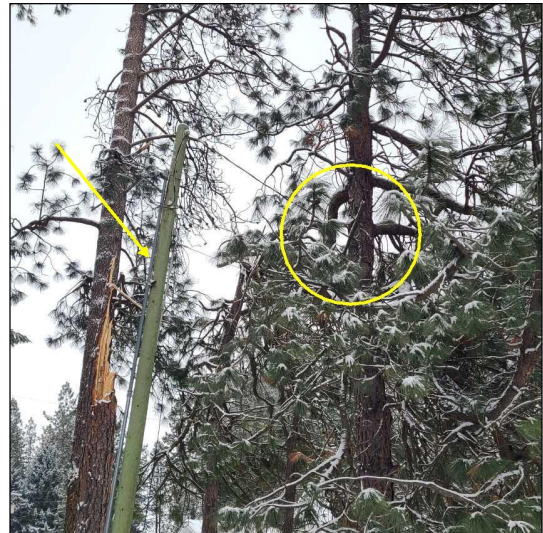
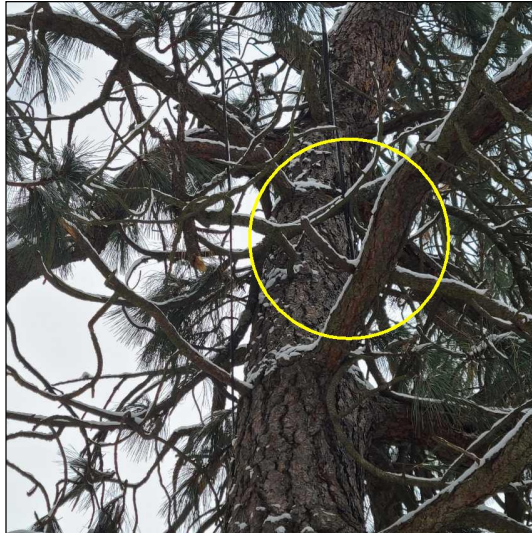
- **Trees in proximity to electric lines are a wind and icing hazard. Contact utility company for trimming.**

Leaning tree.

Tree pulling on power line.

Trees in proximity to electric lines are a wind and icing hazard. Contact utility company for trimming.

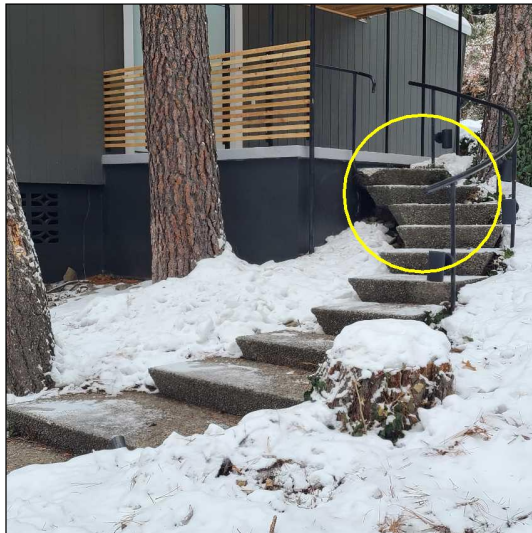
- There were no railings installed at the lower section of steps. Location: Entry steps to front door

Front steps railing not to end of steps.

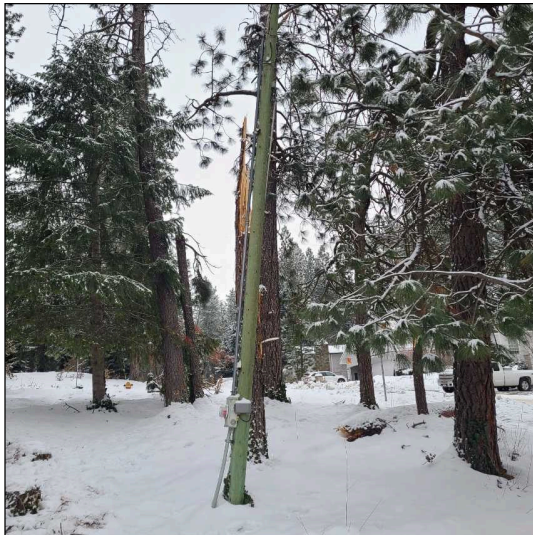
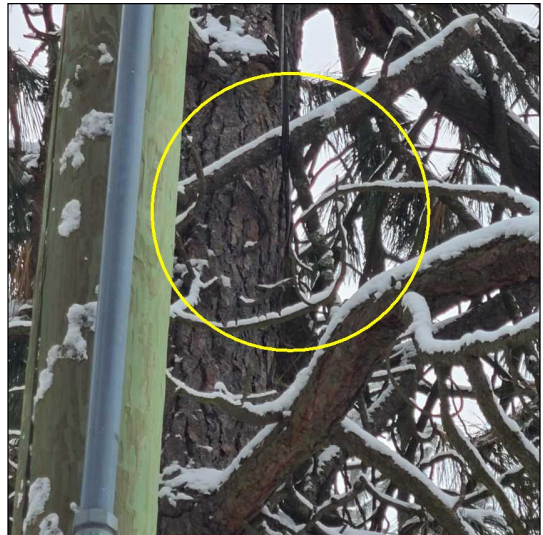
- Service pole for electric is bent, presumably from contact with tree, and cable is abrading against tree trunk.

Leaning electric pole.

Power lines in contact with tree

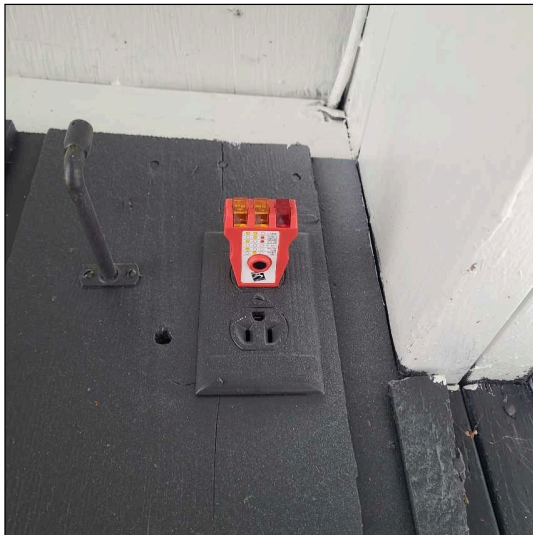
No power to outside outlet.

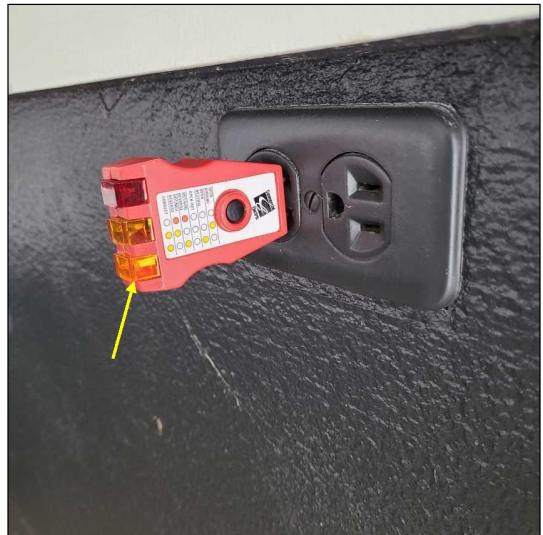
Neutral fault on outlet outside west wall

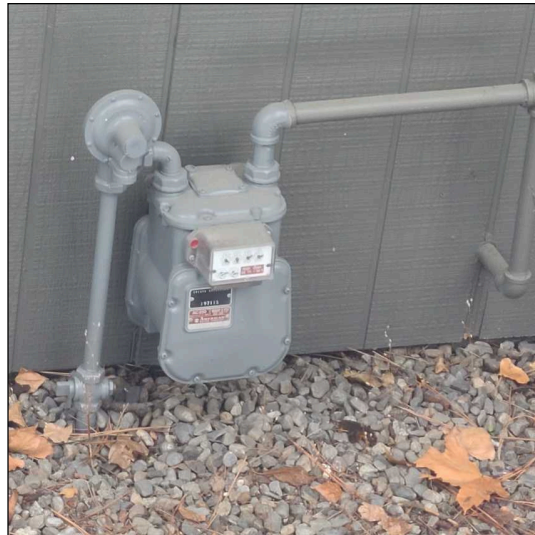
- Meter located at exterior. All gas appliances have cut-off valves in line at each unit. No gas odors detected.

Natural gas meter at rear of home

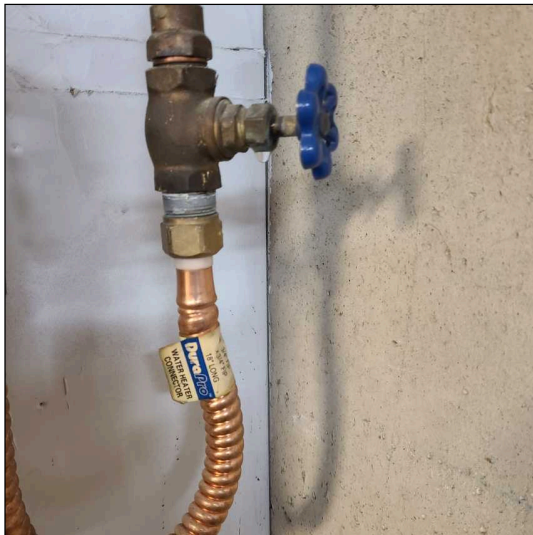
- Water leaking from water shut off in garage at time of inspection. Recommend licensed plumber evaluate and repair.

Water line in garage leaking
